22D Birch Avenue, Toronto, Ontario

SUMMARY INSPECTION REPORT

INSPECTION REPORT

PROPERTY: 22D Birch Avenue, Toronto, Ontario

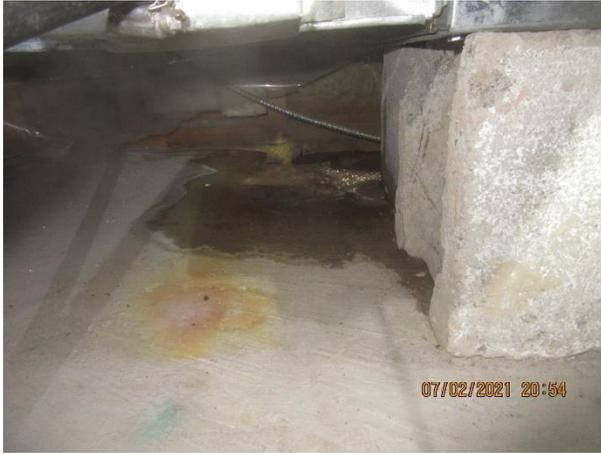
P: there is some standing water below the air handling unit in the garage utility room. The water appears to be due to a leak in the condensate drain from the air conditioner and a service call is required.
